# **PISA TOWER**

## **CONSOLIDATION AND RESTORATION**

**Consorzio Progetto Torre di Pisa**  
BONIFICA – ENEL.HYDRO – ITALSONDA – RODIO – TREVI

**Dr. Eng. Marco Ziller**  
Technical Director of the Consortium

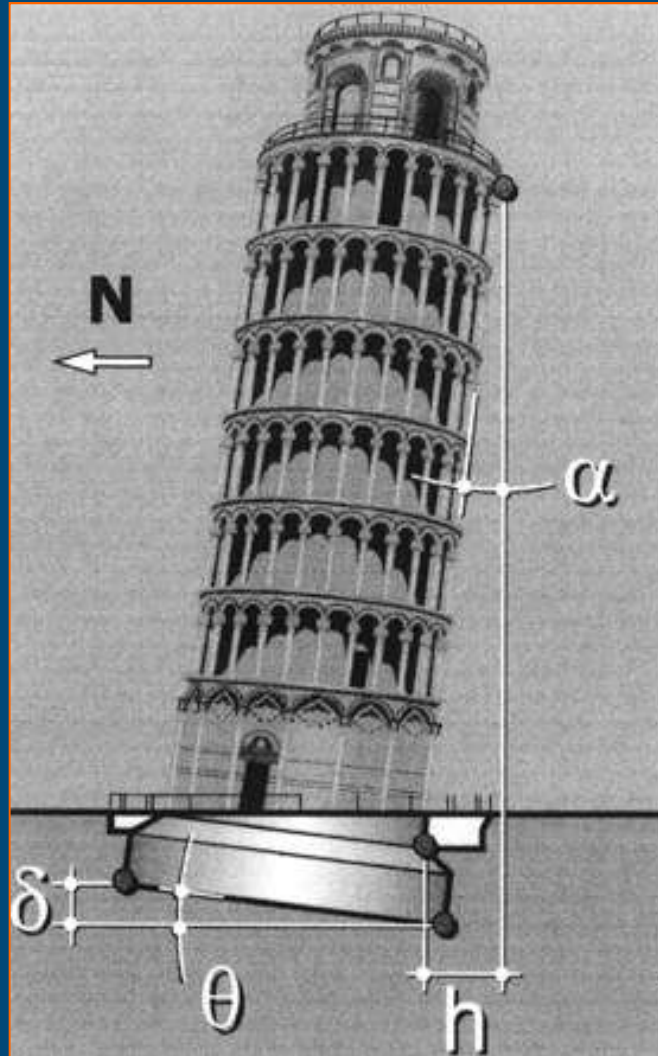
Maximum inclination before the application of the lead counterweight in May 1993/1995

$$\theta = 5^{\circ} 33' 36''$$

$$h = 4.47 \text{ m}$$

$\delta$  = differential settlement of the base  
~1.95m

$h$  = horizontal displacement of the tower  
at the 7° level =4.47m

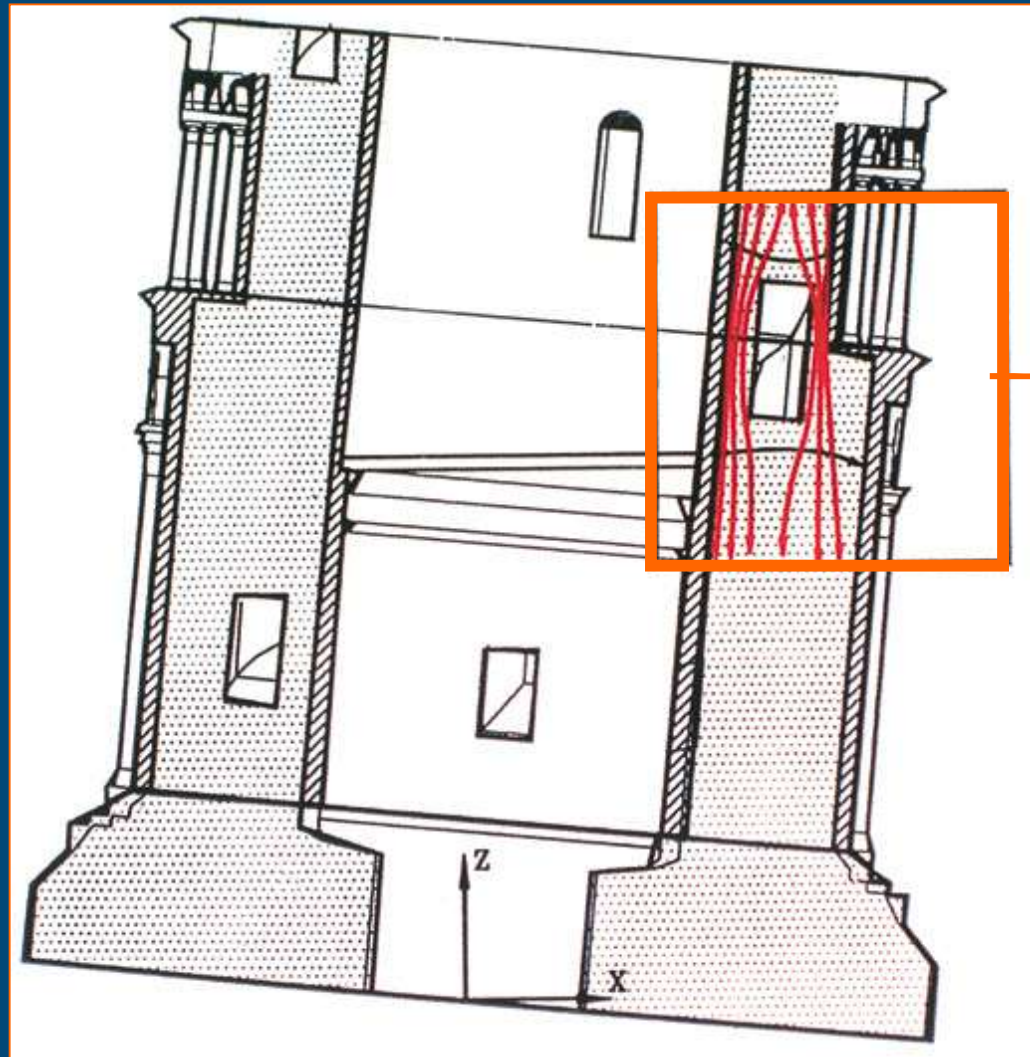
## Structural Analysis Tomography

Fear of a brittle failure  
of the masonry:  
Max pressure 8MPa =  
80 Kg/cm<sup>2</sup>

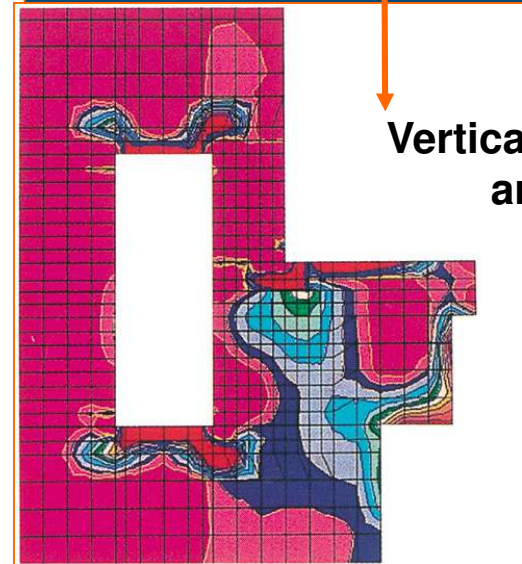
**Vertical fissures  
and cracks**

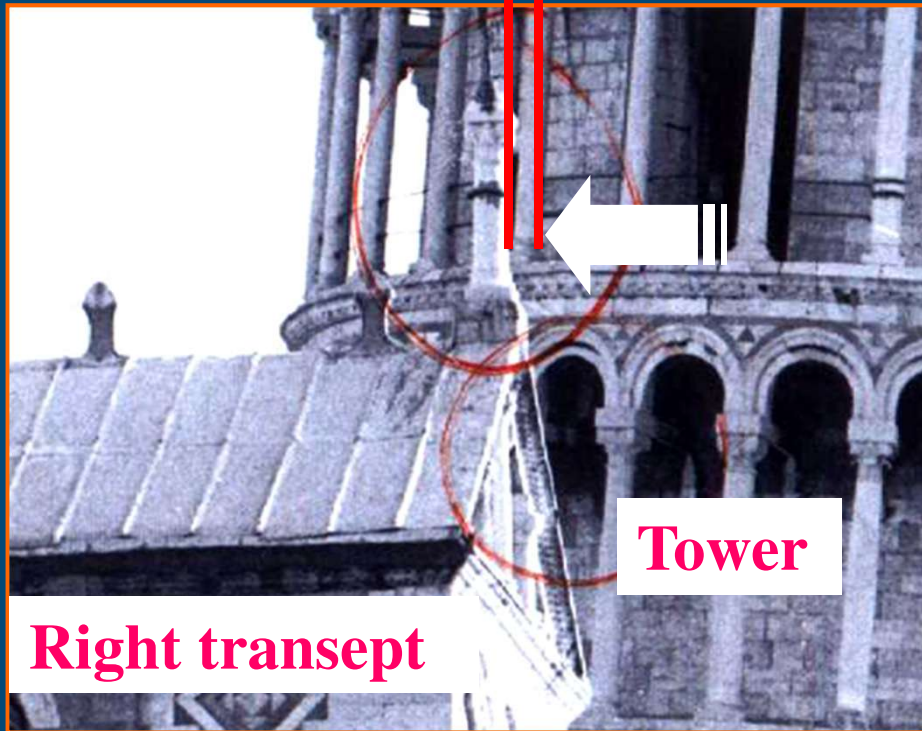
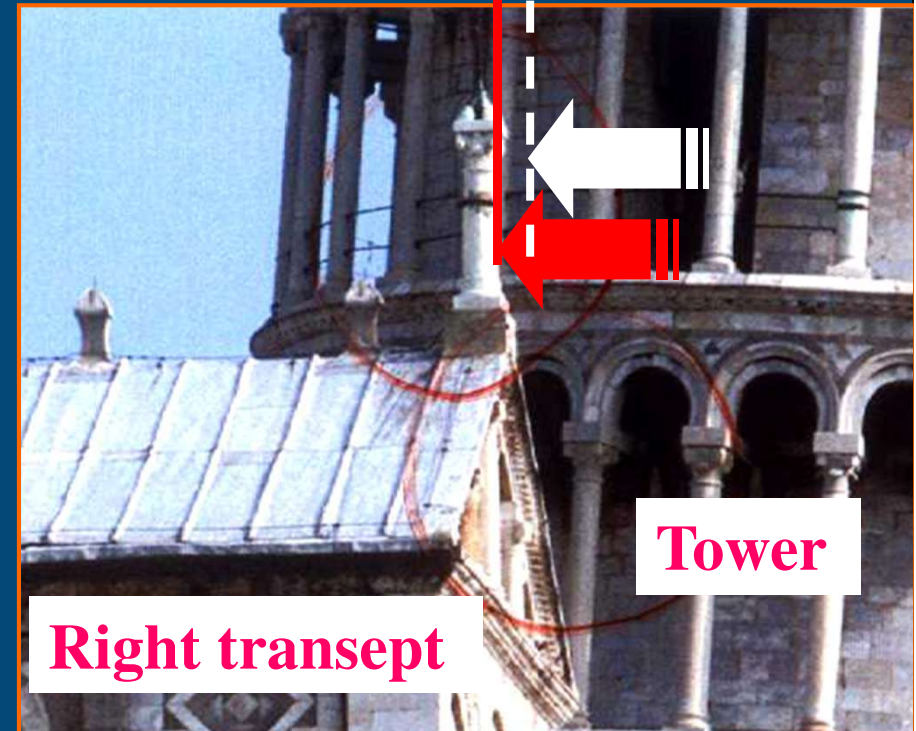
Distance between  
pinnacle and column C  $d = 43.3\text{cm}$

Distance between  
pinnacle and column C  $d = 0$
